# Current Status of Agricultural Machinery in the Mechanization Centers of Bolivar Province, Ecuador

## *Estado actual de la maquinaria agrícola en los centros de mecanización, provincia de Bolívar, Ecuador*

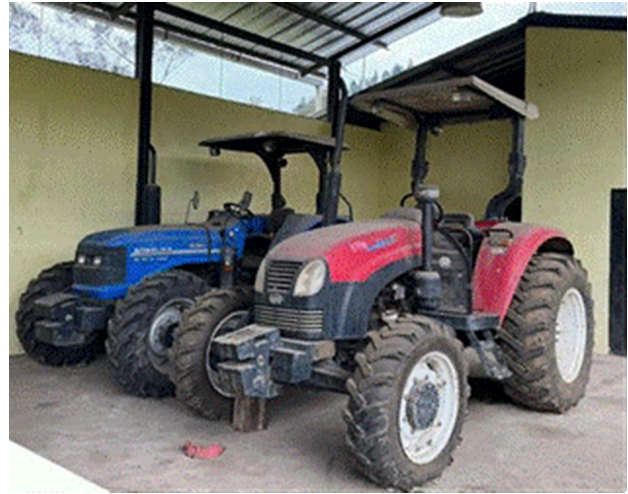
A total of 17 tractors were identified in the 10 machining centers under study, distributed between two main brands: seven YTO (41%) and ten Sonalika (59%) (Figure 1). The YTO- X704 model from the year of manufacture 2009 has a power of 70 hp with a 4x2 traction system, while the Sonalika DI-90RXTURBO4ED model manufactured in 2015, has a power of 90 hp and a 4x4 traction system. All of the tractors began operating in agricultural production in 2015. The preference for these brands is due to the fact that they were acquired as part of the agricultural mechanization program promoted by the Ecuadorian state in 2015.

FIGURE 1. Types of tractors in mechanization centers.

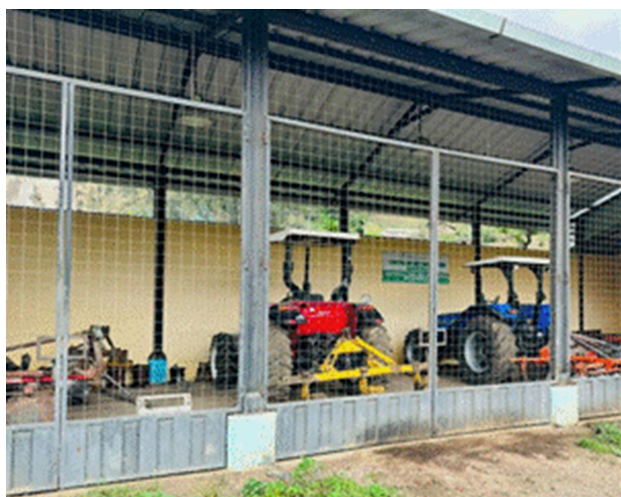
The shelter and storage of machinery is an important factor in its conservation. The ten mechanization centers have sheds to protect the machinery; 100% of them are in good condition (Figure 2). Both the agricultural machinery and the infrastructure were provided to the organizations through a total subsidy from MAG. Previous studies indicate that prolonged exposure to the elements can reduce the useful life of tractors by up to 40% due to the degradation of key components (García *et al.*, 2023).

**FIGURE 2.** Machinery guarding at the machining centers.
